STAGE 1 AND 2 ARCHAEOLOGICAL ASSESSMENT OF THE PENN
ENERGEY - RIDGEFIELD SOLAR PROJECT, PART LOT 5,
CONCESSION 10, GEOGRAPHIC TOWNSHIP OF FENELON, CITY OF
KAWARTHA LAKES.

FIT Application # FIT-FITFRZ1
FIT Contract F-001549-SPV-130-505

From:
Northeastern Archaeological Associates Ltd.
Licenced to: Dr. Lawrence Jackson (P-025)
PIF#: P-025-223-2011

December 20, 2011

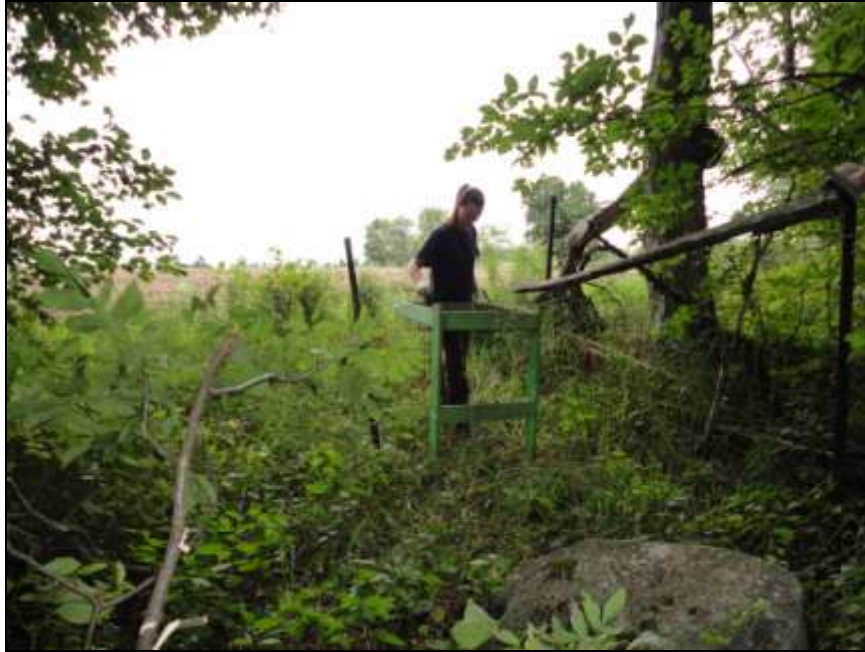
Image 9.1: Oriented SE, Test-Pit Survey in Forested Area Bordering North-West Field

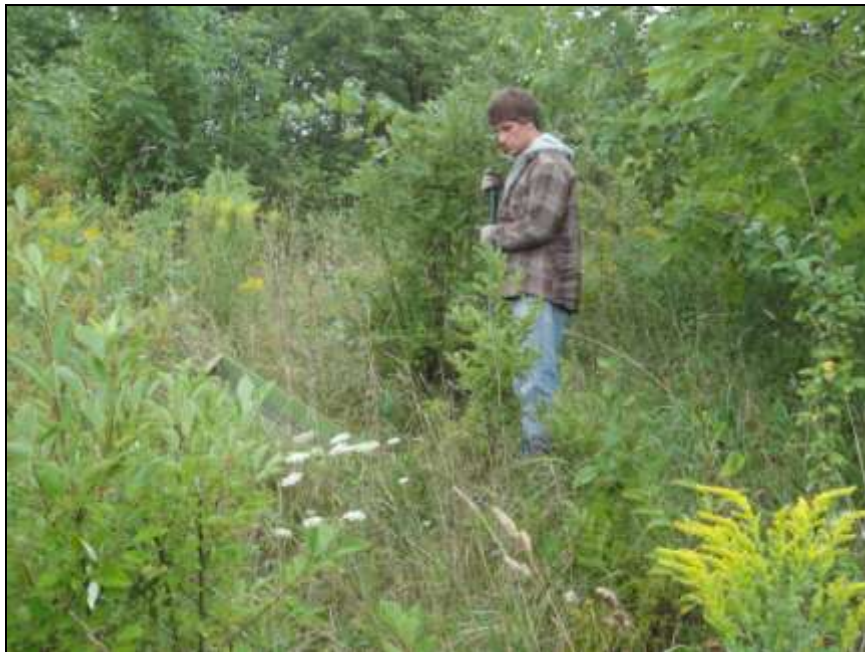
Image 9.2: Oriented NW, Test-Pit Survey on Forested Slope Edge in South-East Portion of Property

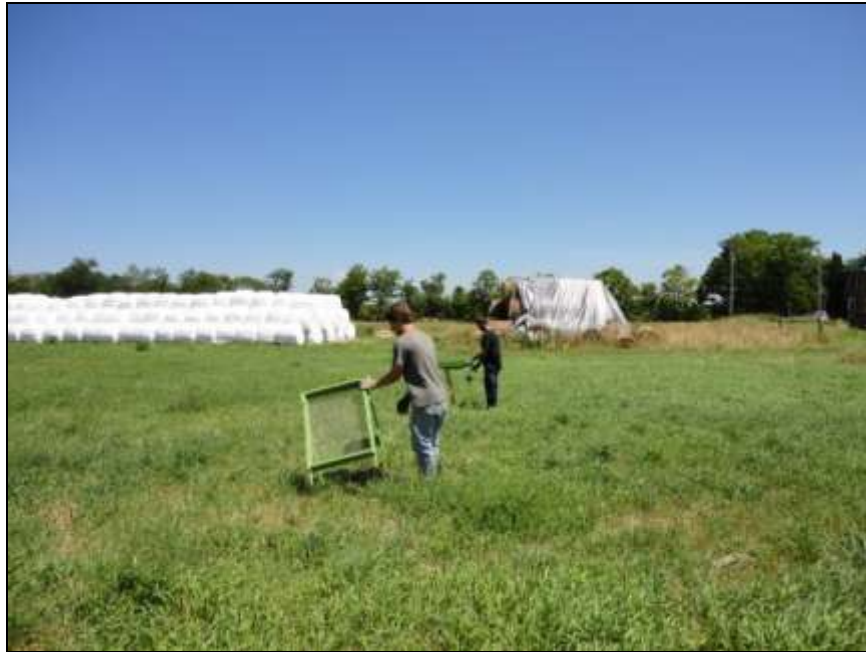
Image 9.3: Oriented E, Test-Pit Survey in Hay Field/Pasture in Northern Half of Property

Approximately 10% consisted of forest bordering the fields (Stand. 1.a. Sec. 2.1.2, MTC 2011), as well as an area of hay field/pasture which had not been cultivated in the recent past and was considered to be too heavily compacted and stony to be suitable for ploughing as per Standard 2.b. Sec. 2.1.2 (MTC, 2011). These areas were therefore assessed using test-pit survey. An enclosed barnyard directly south of the barns was also shovel tested due to its small size, high rock content and existing buried drainage tile (Stand.1.b.e., Sec 2.1.2, MTC 2011). All shovel tests were of a minimum diameter of 30cm, and were excavated into the first 5cm of sterile subsoil. Test-pits were examined for evidence of cultural features, stratigraphy, or signs of disturbance. Soil from test-pits was processed using 6mm mesh rocker screens. All units were backfilled. Images 9.1 and 9.2 shows testing in wooded areas while Image 9.3 shows testing in the open pasture and Image 9.4 shows the stony consistency of the soil in this area. Image

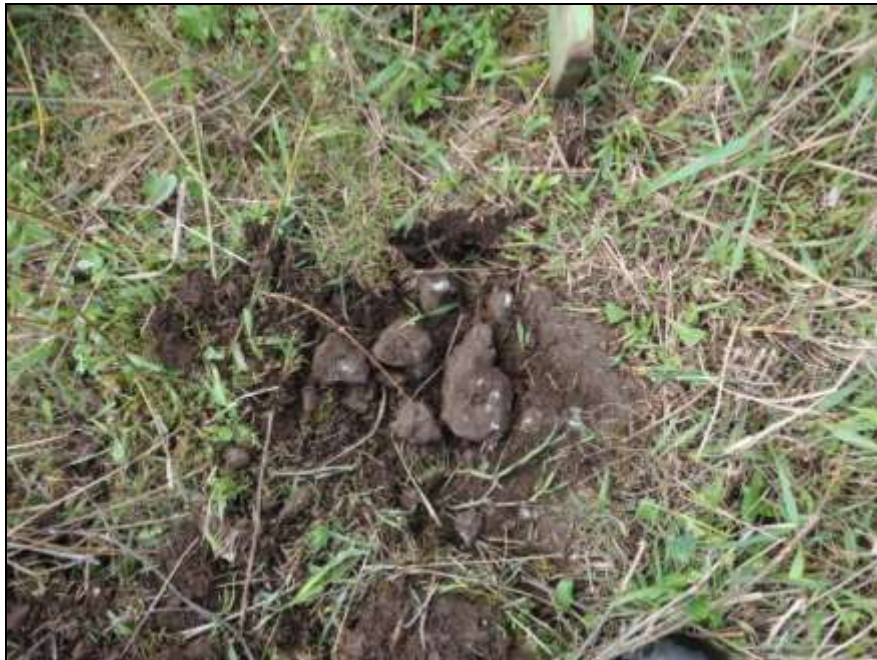
Image 9.4: Photo Showing Thin Sod Layer and Shallow Limestone Horizon in Test-Pit Area From Image 9.3

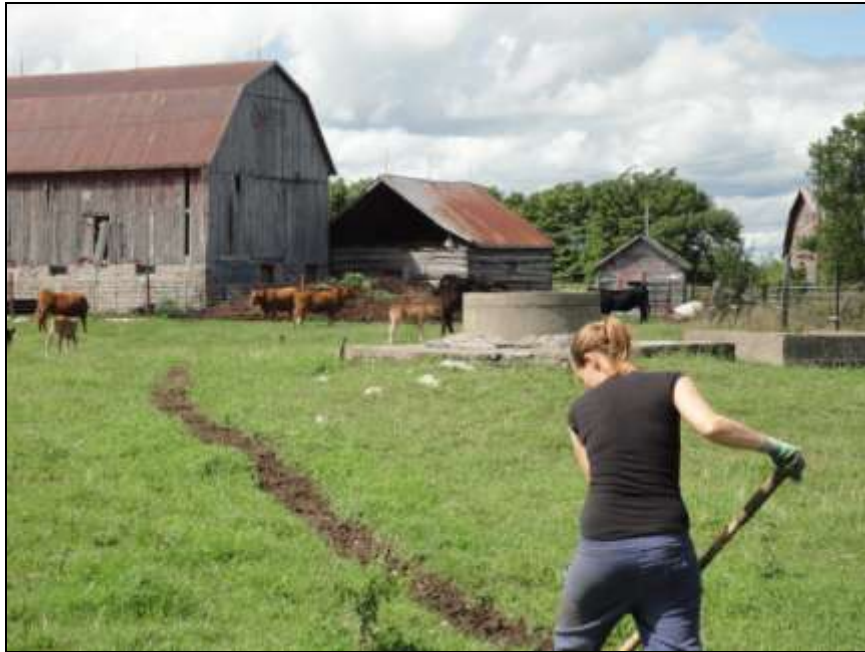
9.5 shows shovel testing within the enclosed barnyard; please note concrete platform and access well to drainage tile bed.

Image 9.5: Oriented N, Test-Pit Survey in Enclosed Barnyard in Central Portion of Property

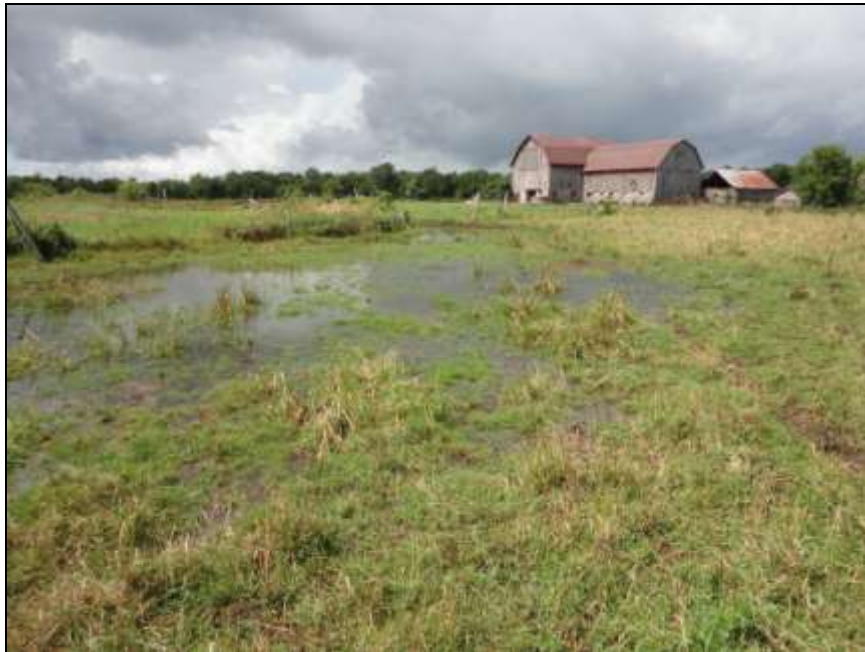
The remaining 2% of the property was covered in surface water. This area, adjacent to the enclosed barnyard in the centre of the property was exempted from testing as per Stand. 2.a.i., Sect. 2.1 (MTC, 2011). Please refer to Image 9.6 for a photo of this area.

Image 9.6: Oriented NW, Area of Permanent Surface Water in Central Portion of Property

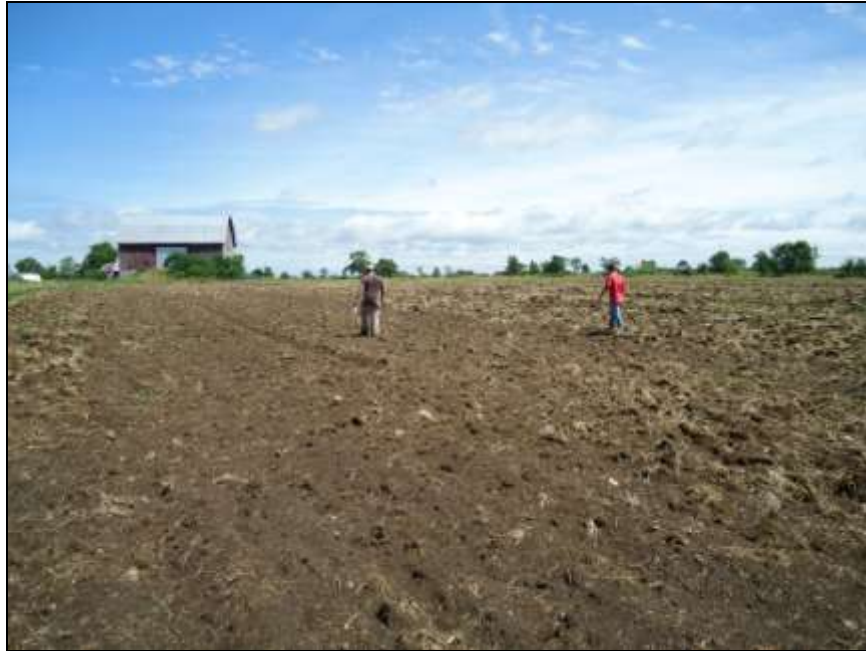
Image 9.7: Oriented E, Pedestrian Survey of Field West of Barn

Approximately 88% of the development property was crop fields and pasture suitable for ploughing as per Standards 1-6, Sec 2.1.1 (MTC, 2011), and was therefore surface surveyed. Please refer to Images 9.7, 9.8, and 9.9.

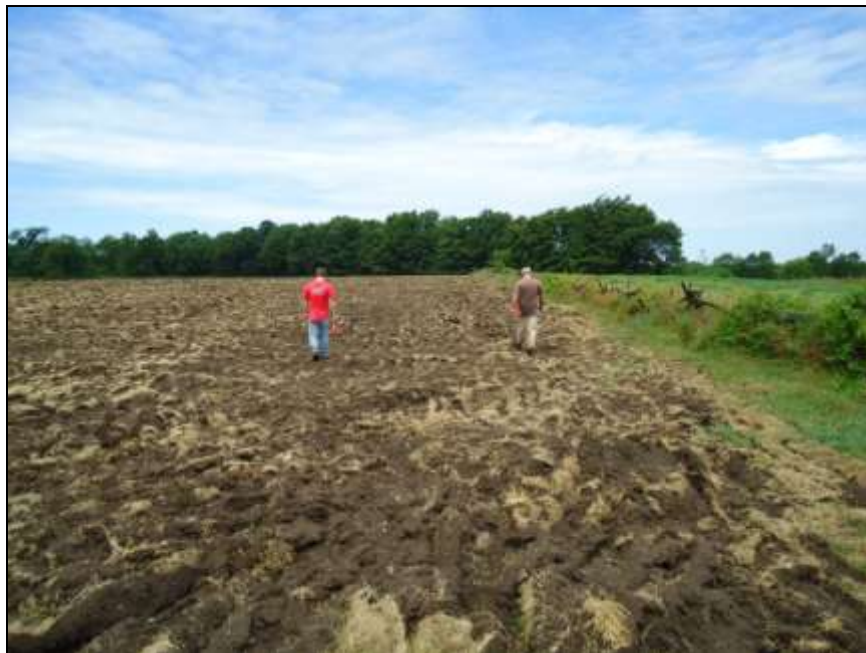
Image 9.8: Oriented N, Pedestrian Survey of Field North of Barn

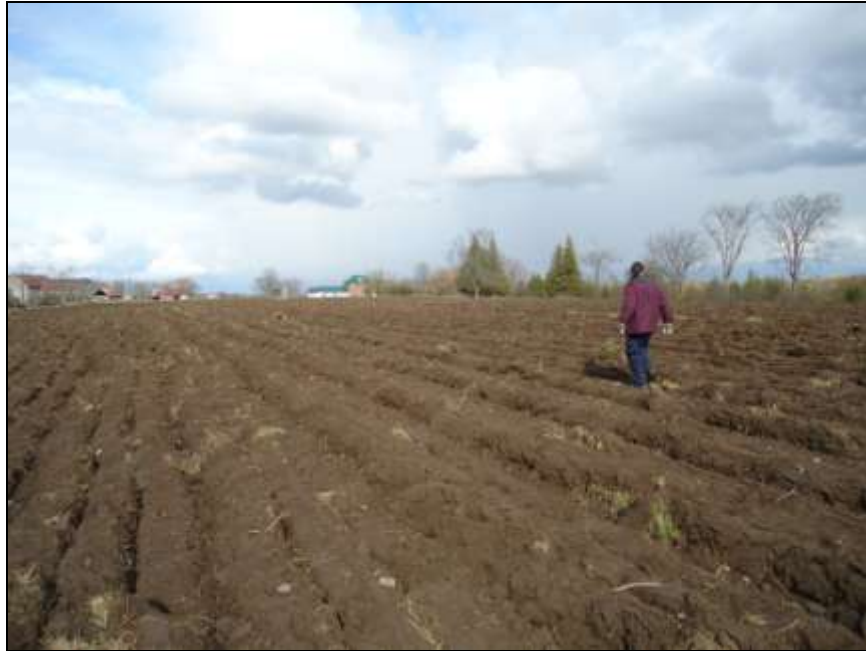
Image 9.9: Oriented NE, Pedestrian Survey of Field South of House

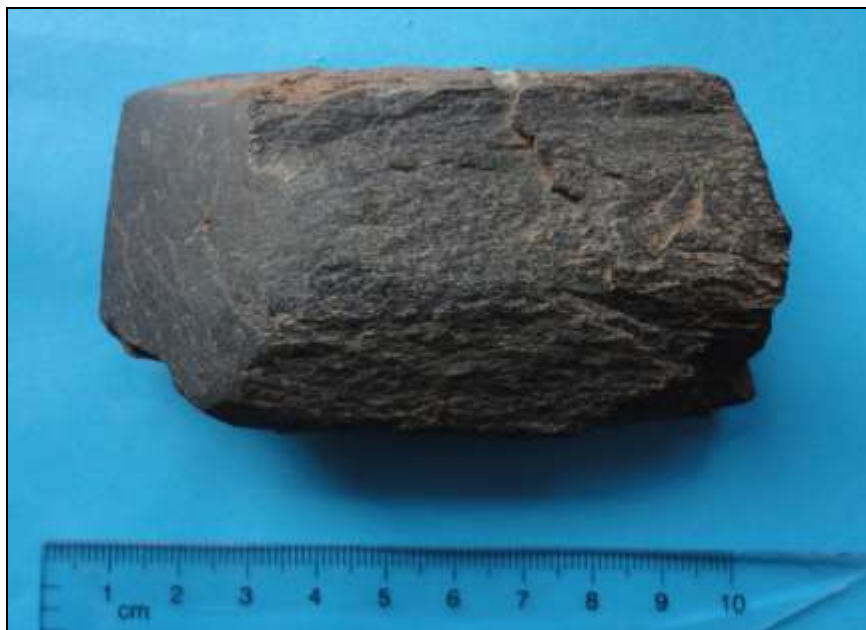
Pedestrian survey in the ploughed field west of the existing barn recovered a single groundstone tool (Image 9.10). Survey intervals were reduced to 1m, and an intensified surface survey was undertaken in a 20m radius around the find-spot as per Stand. 7, Sec. 2.1.1 (MTC, 2011). No additional material was recovered as a result of this intensified search. Please refer to Map 10.2 for the location of this find-spot.

A single groundstone hand adze fragment (Image 9.10) of uncertain affinity was found during pedestrian survey of the field immediately west of the barn. No other cultural material was recovered on the property.

Stage 2 archaeological testing of the subject property conducted in accordance with the Standards and Guidelines outlined by the Ministry of Tourism and Culture resulted in the recovery of a single diagnostic artifact. Subsequent surface survey at 1m intervals failed to locate any associated material. It is the conclusion of this report that the item recovered represents an isolated find spot.

Image 9.10: Groundstone Adze Fragment Found in Field West of Barn

The presence of a single diagnostic artifact does not constitute a site or warrant further archaeological investigation as per Standard 1, Section 2.2 of the 2011 MTC Standards and Guidelines. As no other material was found, either associated with the artifact recovered or otherwise, it is therefore the recommendation of this report that full clearance of the subject property as outlined in this report be granted.

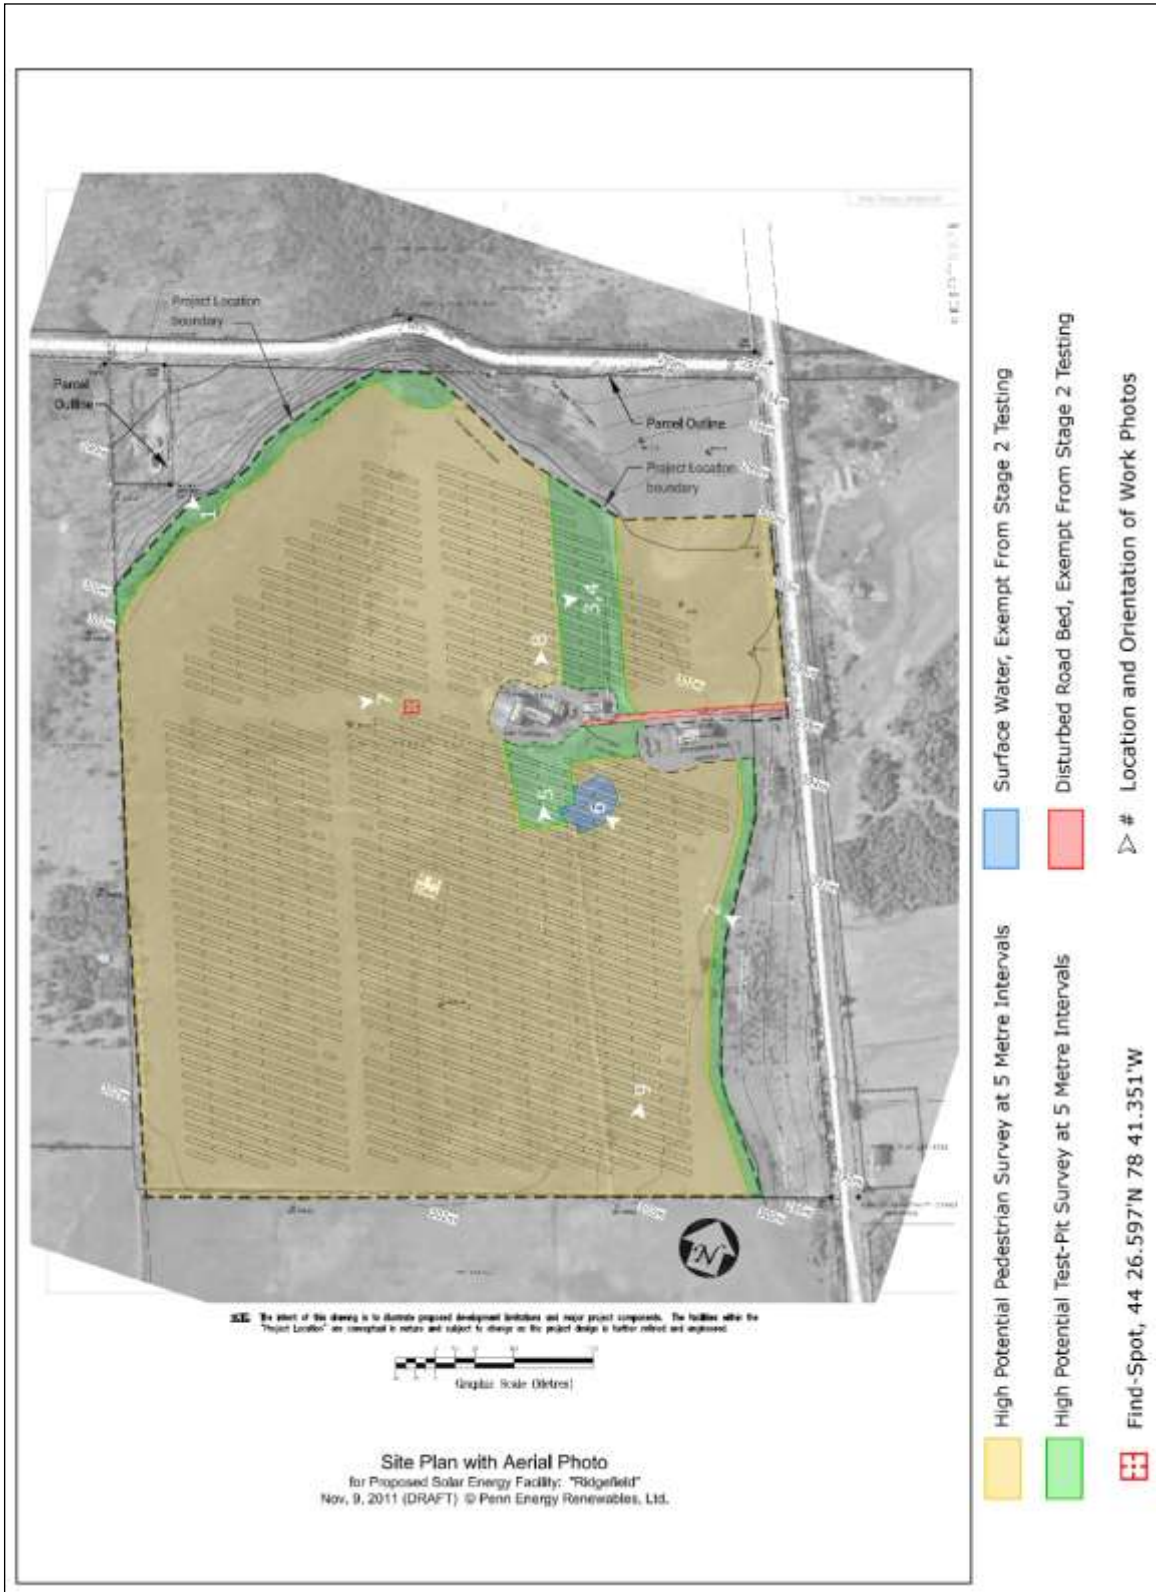
This property is considered high potential according to the 2011 standards set out for Consultant Archaeologists by the Ministry of Tourism and Culture, due to its proximity to Sturgeon Lake, as well as its elevated topography and proximity to areas of historic development. In accordance with these standards, all testable portions of the property were surveyed at a high potential 5 meter test interval. Testing methodology and location/orientation of work photos is illustrated in Map 10.2

Map 10.3: Stage 2 Methodology Overlaid on Draft Plan and Aerial Photo (Original Provided by Penn Energy Renewables, Ltd.)

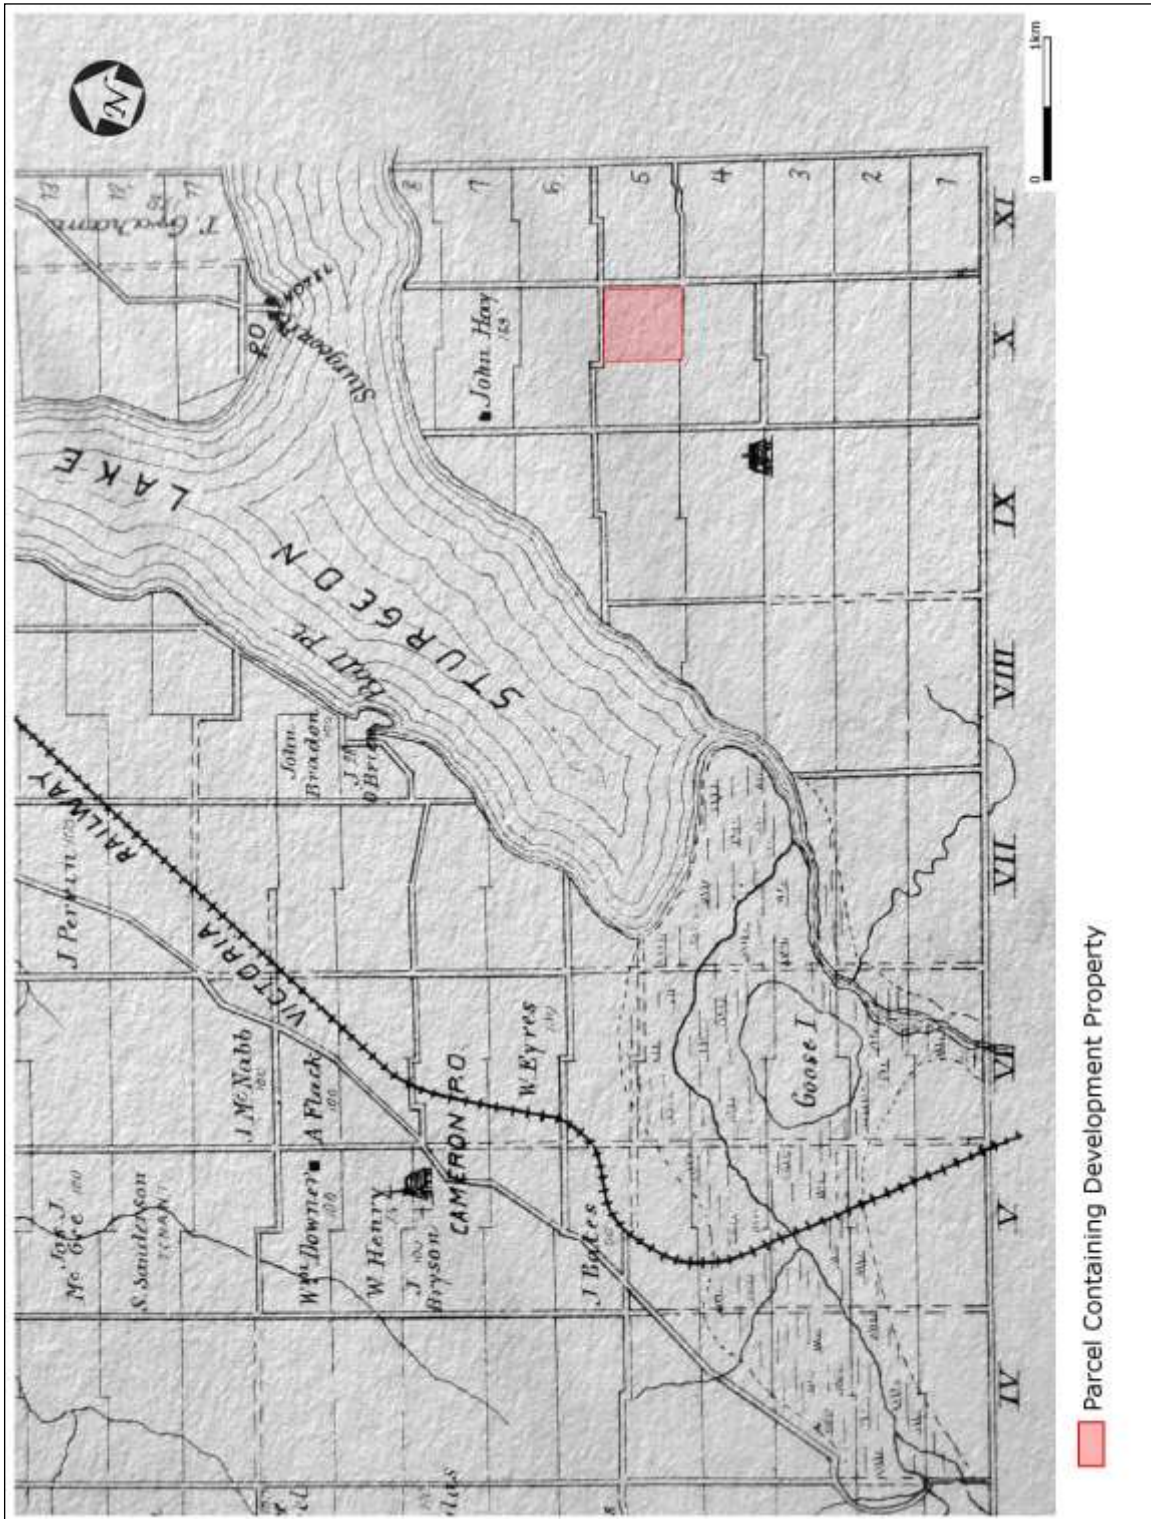
The subject property is the former Township of Fenelon, Victoria County, Ontario. The 1881 Historic Atlas map for the area does not associate a name with the subject property or the majority of the surrounding parcels (see Map 10.4). (Belden & Co. 1881, Alexander Pub. 2000). The 1892 Rural Directory for Victoria County for the Township of Fenelon lists James Brien as the freeholder of lot 5 concession 10. This is consistent with the 1916 Fenelon map which shows a Jas O'Brien as the owner (Belden & Co. 1881, Alexander Pub. 2000). These are very probably the same person, as there is only a slight difference in the names.

Map 10.4: 1881 Historic Atlas Map Showing Location of Development Property (After Belden & Co. 1881, Alexander Pub. 2000)
