# **Penn Energy – Hamilton\_Port Hope-4 SOLAR ENERGY FACILITY**

**In the Township of  
Township of HAMILTON  
Fit Contract No. F-000687-SPV-130-505  
FIT Application No. FIT-FQWKQZF  
COD: May 5, 2012**

## **Water Assessment and Water Bodies Report**

**Prepared by:**  
Bowfin Environmental Consulting  
168 Montreal Road, Cornwall, ON K6H 1B3

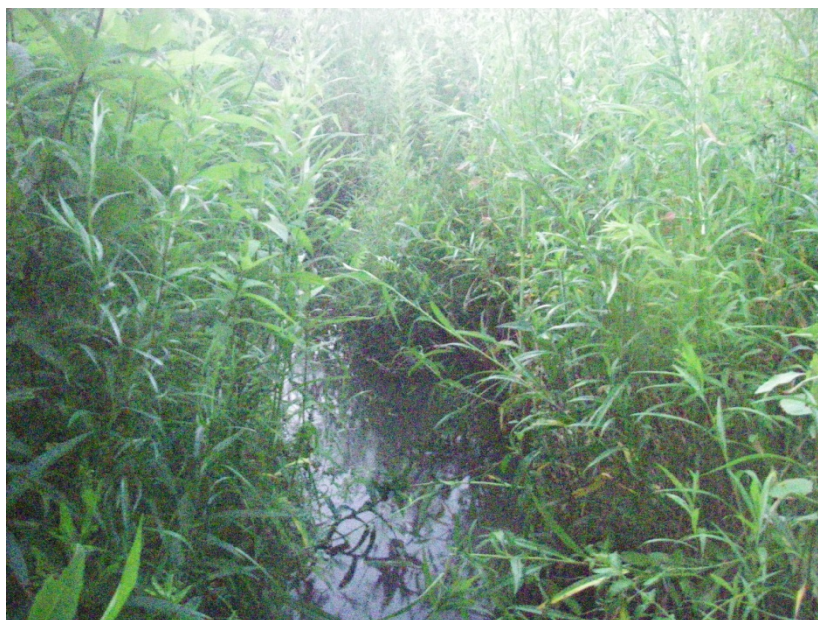
Site 1 was 40 m long (Figure 6). The water temperature was 16.0°C at 2120h, pH was 8.18, conductivity was 471 µs, TDS was 239 ppm, and the air temperature was 24.0°C. The cool water temperature compared to the air temperature indicated that groundwater upwellings were present. The average channel and wetted widths were 149 cm and 82 cm. The average bankfull depth was approximately 20 cm and the average water depth was 5 cm (range 1 – 16 cm). The habitat type consisted of glide (60%), riffle (20%), and run (20%) morphological units. Some pool and riffle habitat was observed but did not fall within a point of interest. Small steps (<20 cm tall) were also located within this site. The substrate was composed of fines (48%), pebble (32%), and cobble (20%). In-stream cover was provided at 92% of the points. The in-stream cover consisted of overhanging vegetation, and undercut banks. The riparian area was fully vegetated with herbaceous vegetation dominated by dog-strangling vine and spotted joe-pye-weed. There was no shrub or tree cover.

**Photo 1** Site 1 looking downstream from upstream.

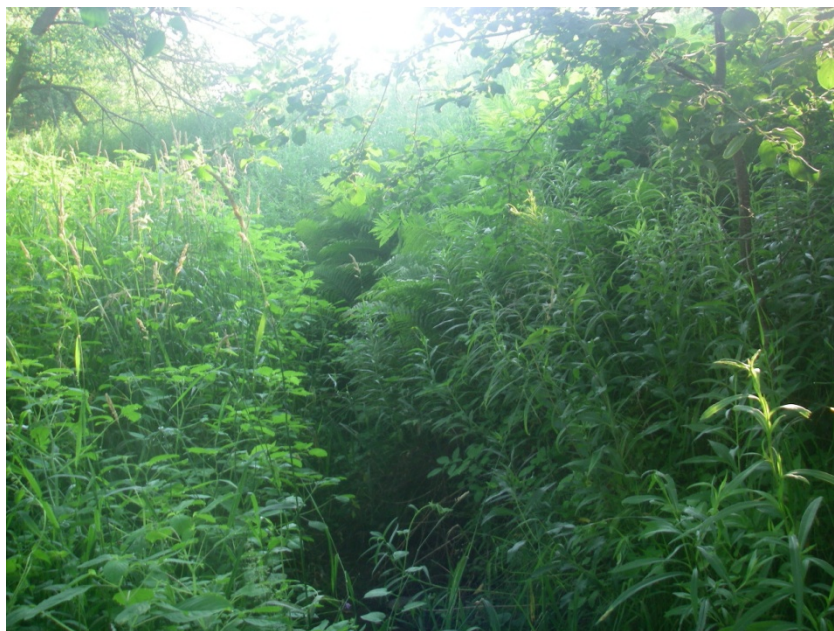
Site 2 was located 690 m upstream from Site 1 immediately upstream of the permanent stream. During the site investigation, the area was dry (Figure 7). The site length was 40 m. The average channel width was 148 cm. The substrate was dominated by fines and followed by cobble, pebble, and gravel. Some large boulders were observed but did not fall within an observation point. In-stream cover was provided at 60% of the points. There was too little water to provide in-stream cover. Some large woody debris was observed but did not fall within an observation point. Banks were undercut. The riparian area was fully vegetated primarily by herbaceous vegetation dominated by spotted jewel-weed, reed canary grass, and goldenrod. Common buckthorn and Manitoba maple were scattered along the banks and provided little stream cover.

**Photo 2**      **Site 2 looking upstream from downstream.**

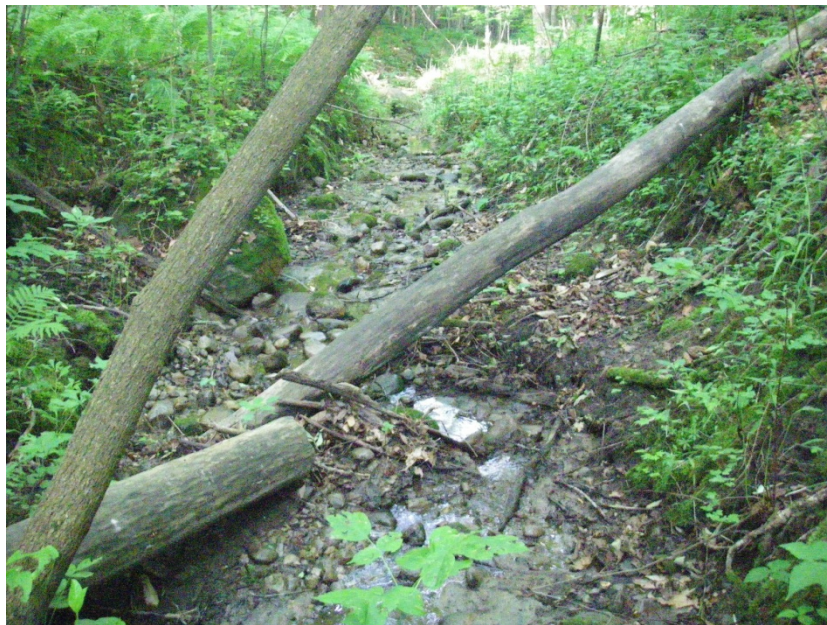
Site 3 was located on the south branch of the middle headwater tributary and was 40 m long. This site had an intermittently defined channel (portions of the stream travelled underground and was indistinguishable from the surrounding areas) (Figure 8). Water was present throughout the above ground portions but in very small amounts. The water temperature was 14.0°C at 0820h, pH was 7.92, conductivity was 460 µs, TDS was 232 ppm, and the air temperature was 19.0°C. The average channel and wetted widths were 138 cm and 44 cm. The average bankfull depth was approximately 14 cm and the average water depth was 1 cm (range 0 – 3 cm). The habitat type consisted of run morphological units. The substrate was composed of fines (68%), pebble (20%), and cobble (12%). There was too little water to provide in-water cover. Banks were undercut. The riparian area was fully vegetated by herbaceous and woody vegetation. The herbaceous vegetation was dominated by ostrich fern, wood nettle, and jack-in-the-pulpit. The woody vegetation consisted of trees that provided good canopy cover. The tree species were: sugar maple, shagbark hickory, and white cedar.

**Photo 3**      **Site 3 looking downstream from downstream.**

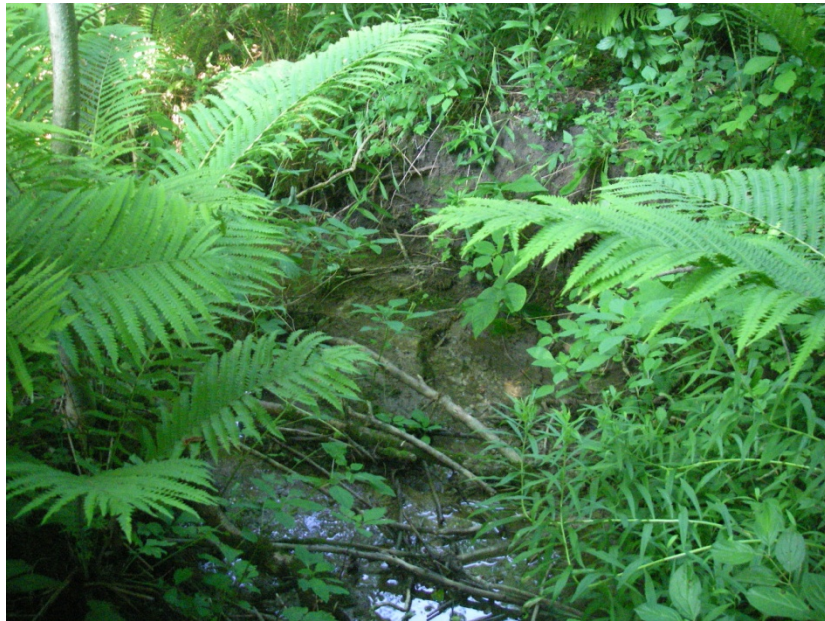
Site 4 was located on the north branch of the middle headwater tributary and was 40 m long. This site had an intermittently defined channel (portions of the stream travelled underground and was indistinguishable from the surrounding areas) (Figure 9). Water was present throughout the above ground portions but in very small amounts. The water temperature was 15.0°C at 0848h, pH was 7.94, conductivity was 442 µs, TDS was 222 ppm, and the air temperature was 20.0°C. The average channel and wetted widths were 171 cm and 19 cm. The average bankfull depth was approximately 11 cm and the average water depth was 1 cm (range 1 – 3 cm). The habitat type consisted of run morphological units. The substrate was composed of fines (90%), pebble (5%), and cobble (5%). There was too little water to provide in-stream cover. Some large woody debris was observed but did not fall within an observation point. Banks were eroding. The riparian area was fully vegetated by herbaceous and woody vegetation. Herbaceous vegetation was dominated by ostrich fern followed by wood nettle, and jack-in-the-pulpit. The woody vegetation consisted of trees and provided good canopy cover. Tree species included: sugar maple, shagbark hickory, and white cedar.

**Photo 4**      **Site 4 looking upstream from downstream.**

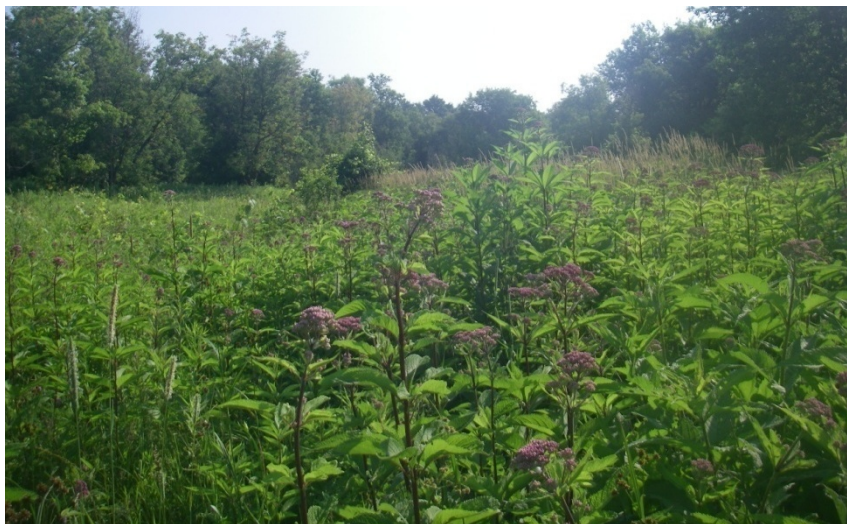
The man-made pond consisted of an earthen berm at the upstream end of the fully vegetated swale near the house (Figure 10). The swale within the study area was vegetated primarily with spotted joe-pye-weed. The banks were dominated by reed canary grass followed by goldenrod sp., and spotted joe-pye-weed. There was no shrub or tree cover. There was no water present and no signs of seepages (no iron staining, no water-cress).

**Photo 5 Site 5 looking upstream from downstream.**

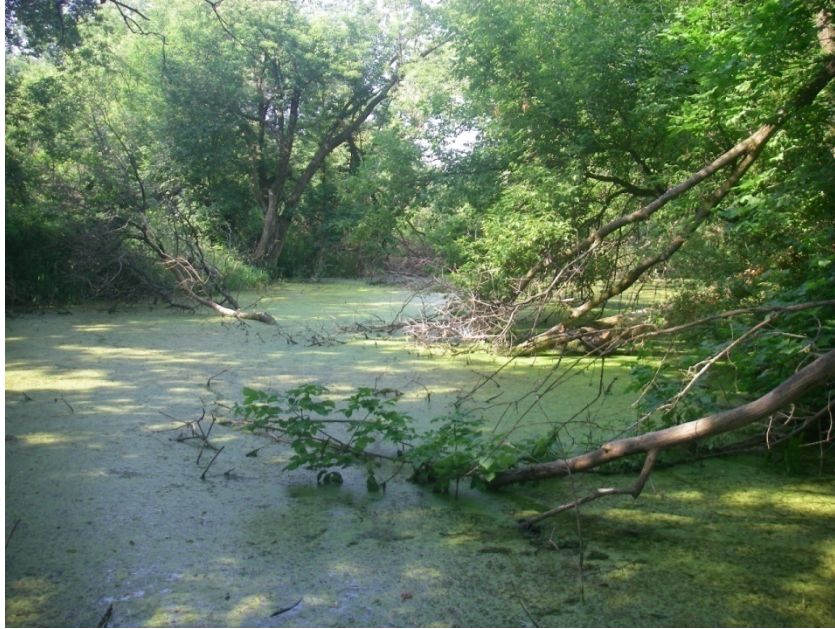
The pond's length was 40 m, and the width was 15 m. The substrate was composed of fines. The maximum depth was 75 cm. In-stream cover was provided by dense aquatic vegetation, and large woody debris. The aquatic vegetation was dominated by lesser duckweed, and great duckweed followed by reed canary grass, and spotted joe-pye-weed. The riparian area was fully vegetated. Herbaceous vegetation was dominated by spotted jewel-weed followed by riverbank grape, and reed canary grass. The little canopy cover provided by crack willow, and Manitoba maple. The man-made pond doesn't meet the definition of a water body and would be more appropriately labelled as a dugout pond. There were no seepage areas associated with the man-made pond (no iron staining, no indicator plants such as water-cress and water temperature did not indicate the presence of groundwater).

**Photo 6** Taken from the north side looking south

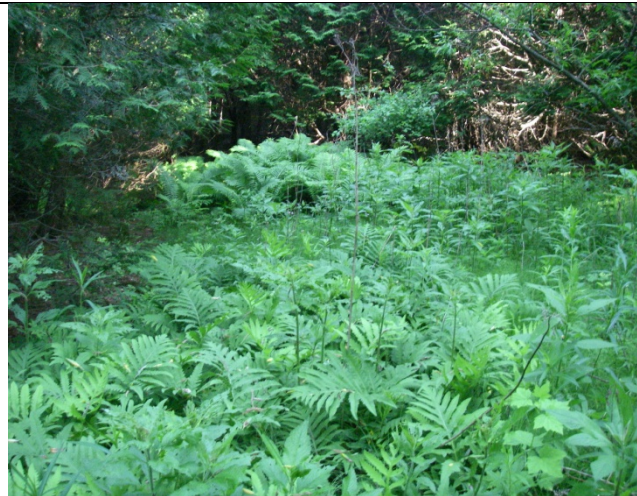
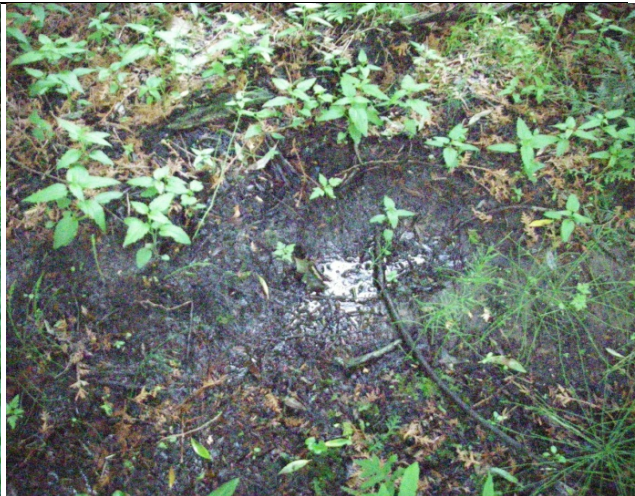
In addition to the groundwater upwellings which were present within the streams described above, an isolated seepage area was located on the edge of the pine plantation on the western side of the study area. The seep contained the following vegetation: field horsetail, spotted joe-pye-weed, sensitive fern, crack willow, ostrich fern, Virginia creeper, sparse-flowered thimbleberry, awl-fruited sedge, bittersweet nightshade, and cut-leaved water-horehound.

**Photo 7 Looking at the seepage area, June 15, 2010**

**Photo 8 Looking at the seepage area, June 15, 2010.**
